Chevy P30 Chassis – J71 Auto Park Brake Revision

Our motorhome has a 1998 Chevrolet P30 chassis with the J71 auto park brake. This means that we, along with many others with the Chevy P30 chassis with the J71, have experienced the sudden, and scary, engagement of the park brake while driving—the dreaded Chevy P30 park brake failure. In this situation, the park brake, without warning and without driver input, engages and locks up, creating a hazardous—and unnerving—driving emergency.

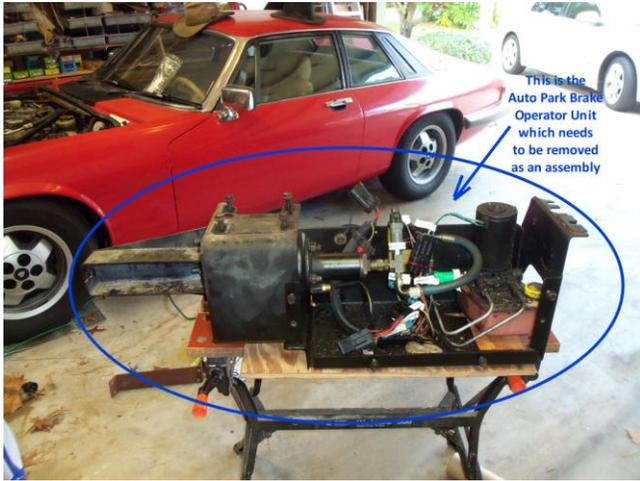
The park brake unit, which will be removed as a single assembly. It is heavy, so use a lift such as a transmission jack or a large floor jack which has a large cradle.

There is more weight toward the left end, where the hydraulic cylinder and spring is. You may need to adjust the balance of the unit on the lift/jack, as it takes the weight of the unit.

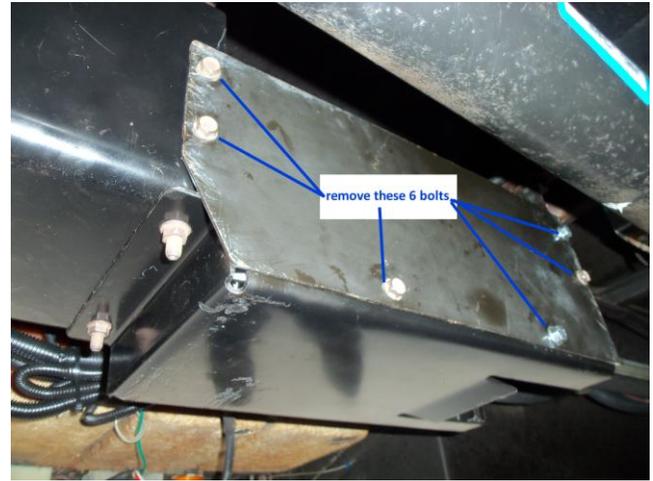
Step 1—Removal of park brake access cover plate.

Remove this access cover plate by removing the 6 bolts. (If yours is like mine was, two of these bolts were not replaced during a previous service; the photo shows the access cover back in place after I installed the new assembly and replaced the missing bolts.)

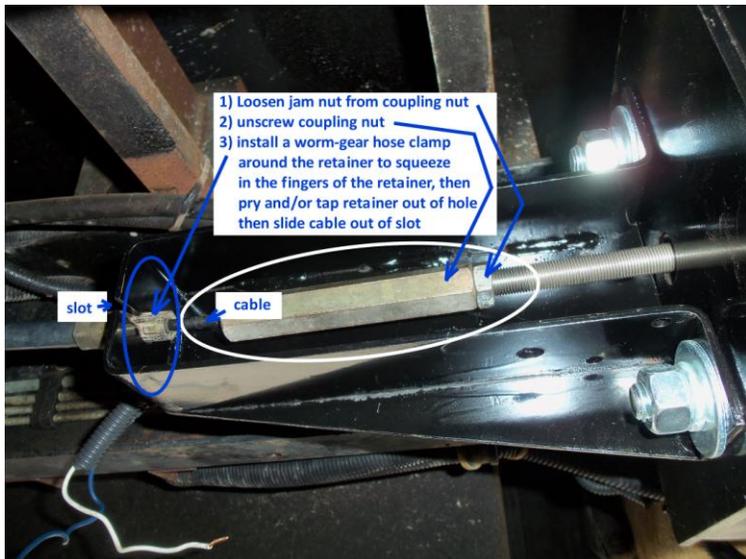
Step 2—Removal of park brake cable from the threaded shaft of the hydraulic cylinder.

The park brake unit is connected to a cable connected to linkage that operates the park brake.
Note: with the park brake released, measure the distance the cables coupling nut is from the housing surface to the right, upon re-installation, this will be the distance you will screw the coupling nut onto the shaft and secure with the jamb not – this will be your adjustment starting point.

- 1) Loosen jam nut from coupling nut.
- 2) Unscrew coupling nut from threaded shaft.
- 3) Install a worm-gear type hose clamp around the retainer to squeeze in the fingers of the retainer, pry and/or tap the retainer out through the hole, then slide the cable out of the slot.

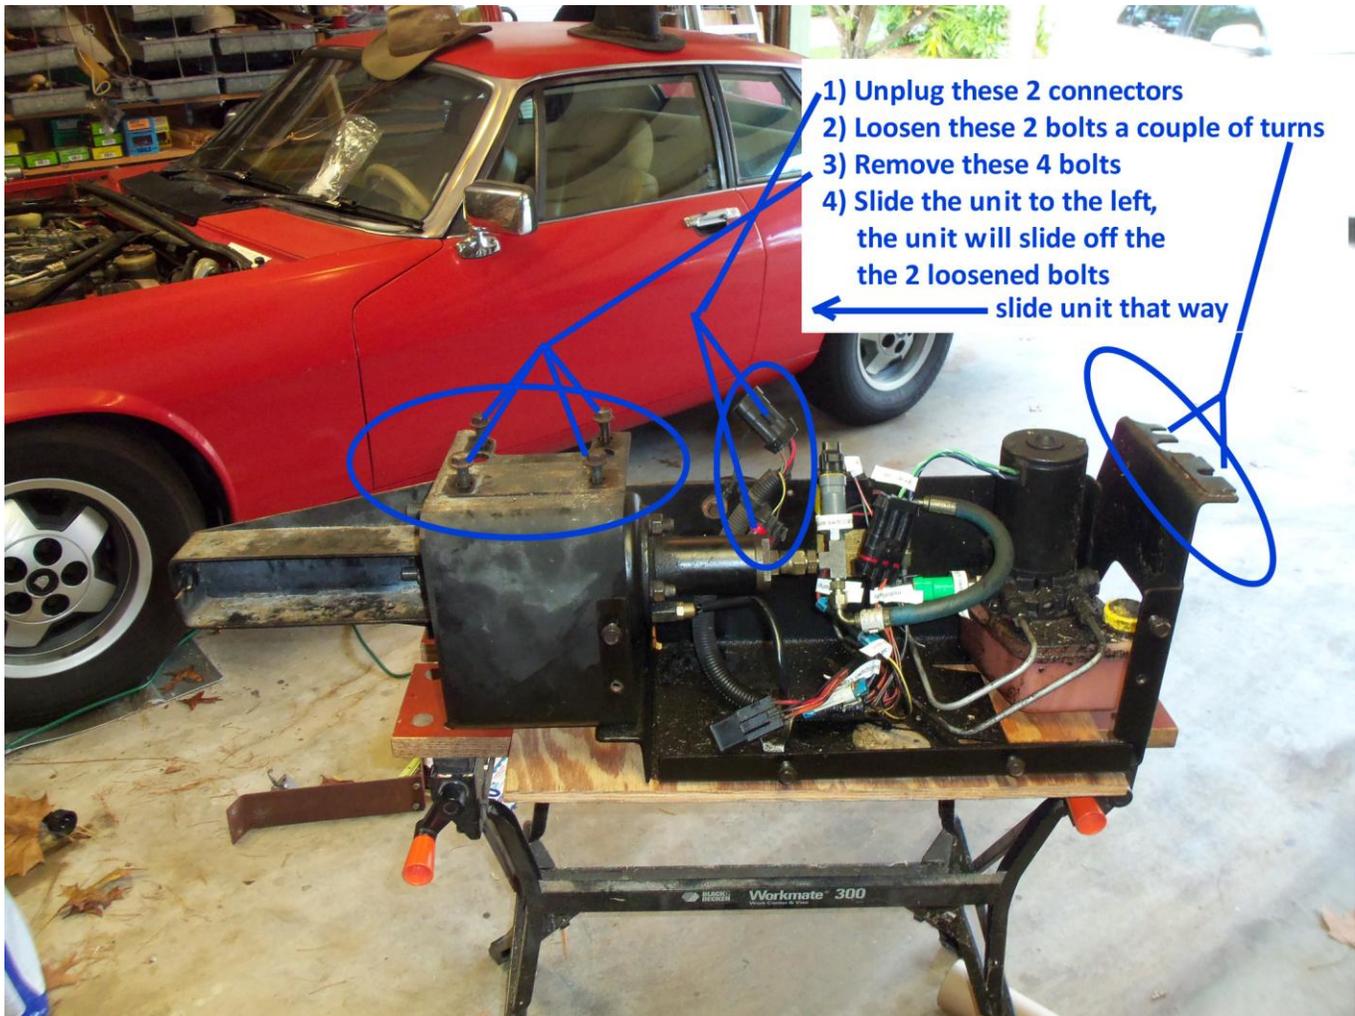
Steps 3 through 9—Removal of park brake unit as a single assembly

- 3) Disconnect the 2 plug-in connectors (Item 1 in photo above) that connect the park brake unit to the chassis wiring.
- 4) Loosen the nuts on the 2 bolts (Item 2 in photo above) at the right end of the unit a couple of turns. **DO NOT REMOVE THE NUTS OR BOLTS** at this time.

- 5) With the lift or jack under the unit to support its weight, remove the 4 front bolts (Item 3 in photo above). **NOTE:** The front (left) end of the unit will be heavier than the rear (right) end of the unit; balance the unit on the lift/jack.

- 6) Lower the lift/jack just enough to make sure the left end of the unit is free from the chassis. The right end should still be hanging from the 2 bolts (Item 2 in photo) that were loosened a couple of turns in Step 4 above.

- 7) Roll the lift/jack, which is supporting the unit, toward the front of the vehicle (keeping the weight balanced on the lift/jack) so the right end of the unit slides off the 2 bolts (Item 2 in photo) at the right end. These two bolts/nuts may be left in place.

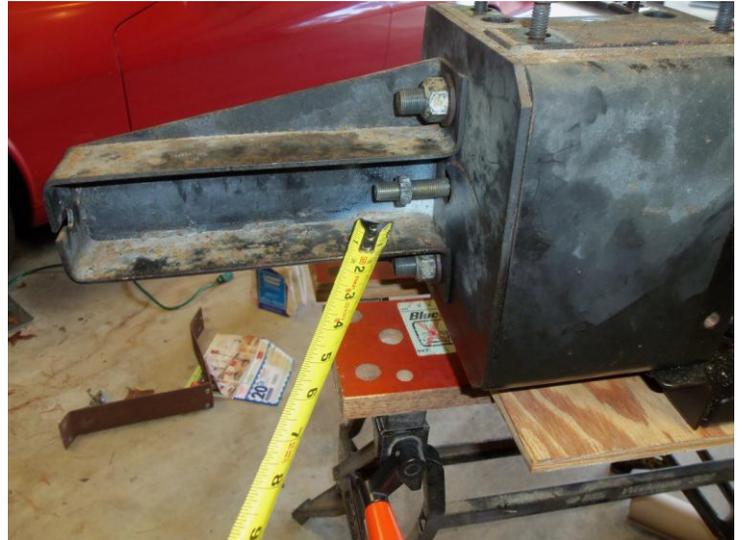
The threaded shaft, which projects out of the hydraulic cylinder and onto which the coupling nut was threaded.

Measure the distance from the end of the threaded shaft to the front plate, as the bolt of the new operator will need to be the same length. The end of the threaded shaft of my hydraulic cylinder measured 1-13/16 inches from the front plate when fully retracted.

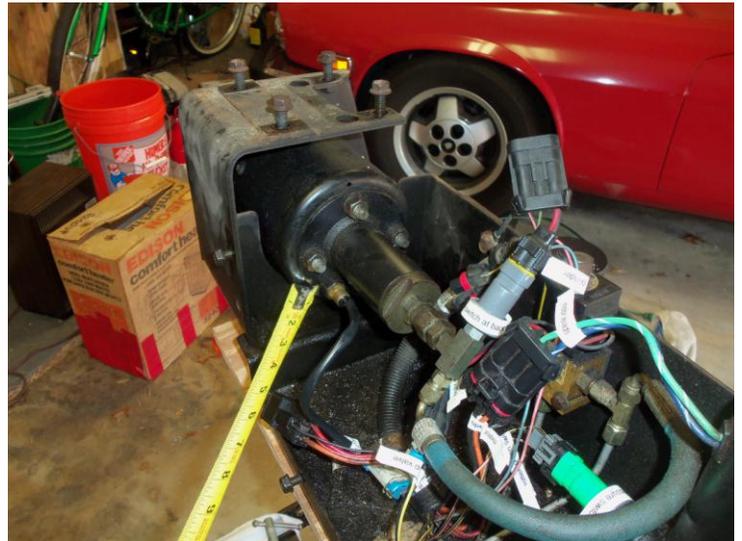
The hydraulic cylinder with the internal return spring.

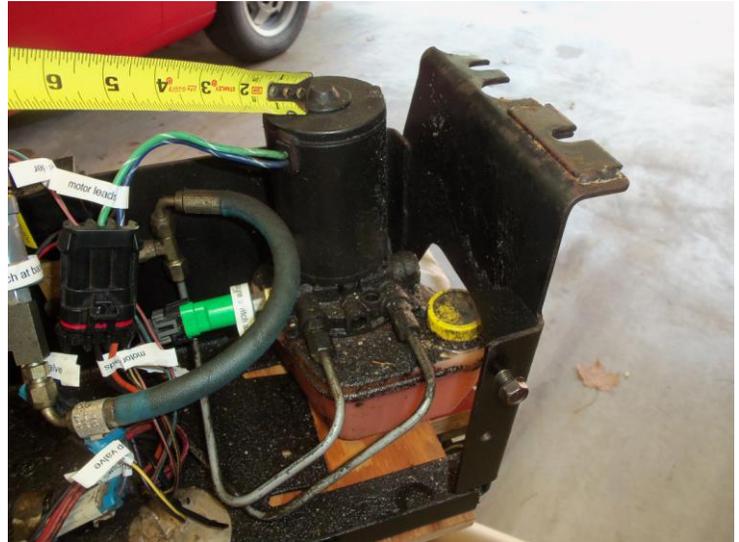
The hydraulic pump motor.

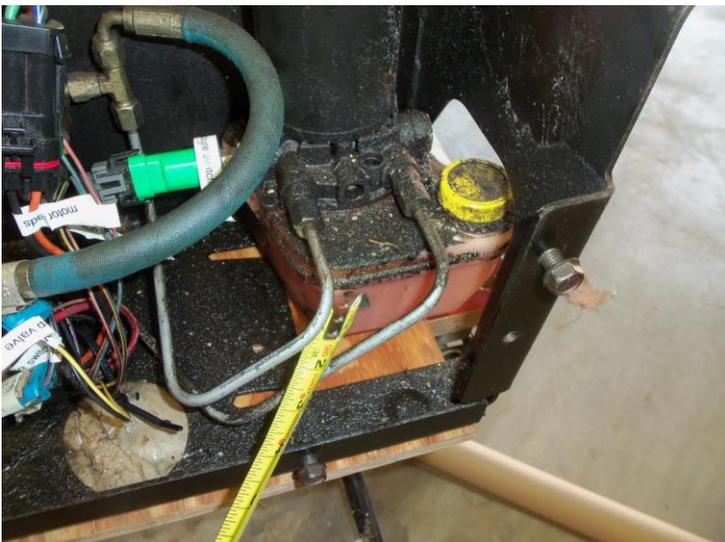
The hydraulic fluid reservoir. The hydraulic pump uses ATF fluid, however, because there will no longer be any need for the ATF fluid there will be no more leakage of it

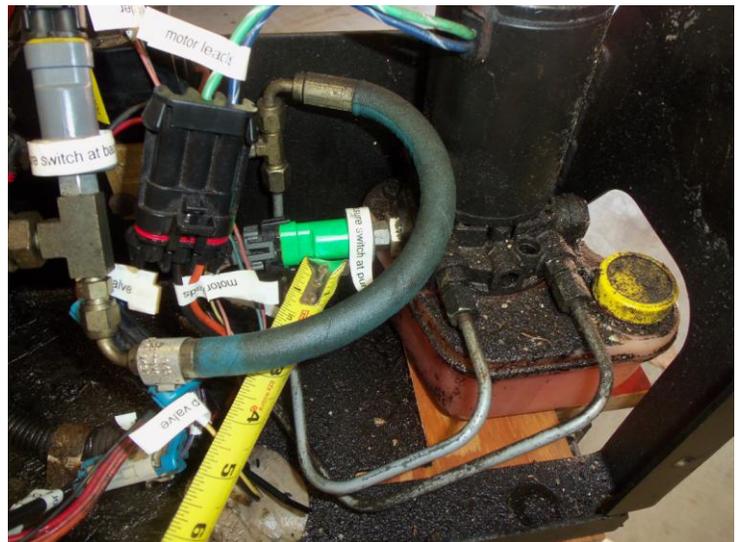
The RGS (Rotten Green Switch) pressure switch which is normally closed with no pressure in the system and the brake is on; this switch is open when there is pressure in the system and the brake is off. This switch senses pump pressure when it is working—i.e., when it is not leaking the pressure out and causes the park brake to engage while driving. I believe this switch operates the Auto Park light or the Parking Brake light (does not matter which).

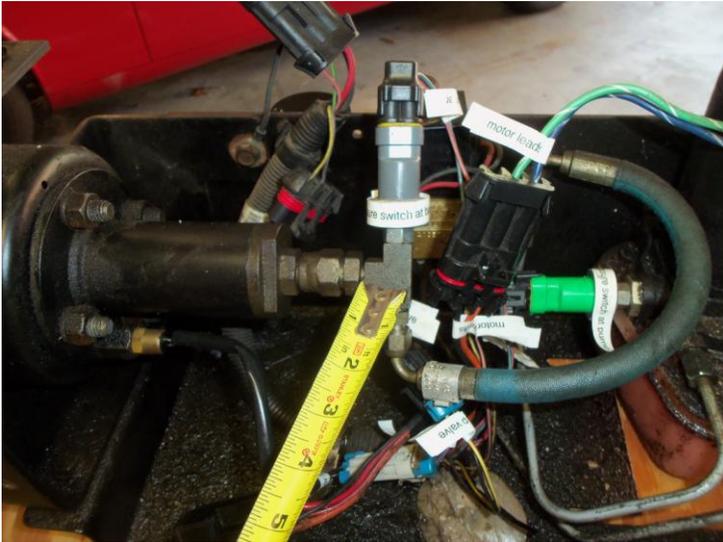
The pressure switch on the inlet to the hydraulic cylinder. It is normally closed (no pressure) when the brake is on and open when there is pressure and the brake is off.

This pressure switch has the same failure mode as the RGS pressure switch. It also may leak, allowing the hydraulic pressure to drop and cause the park brake to engage while driving. I believe this switch operates the Auto Park light or the Parking Brake light (does not matter which).

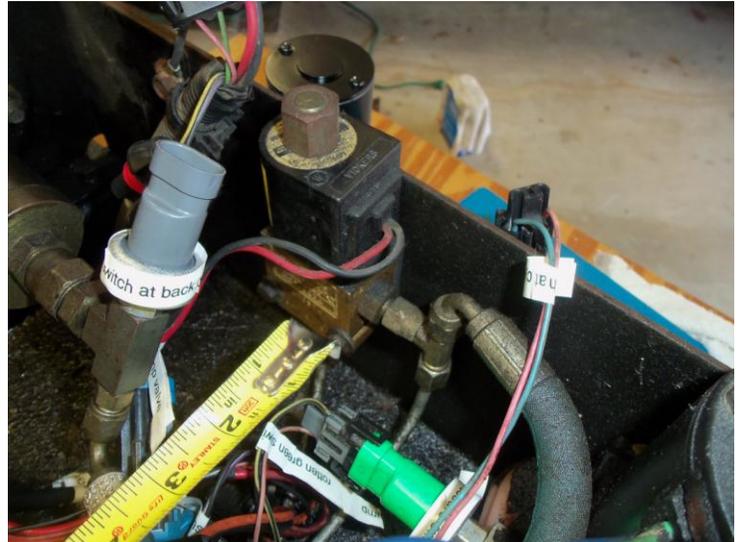
The dump valve which dumps out the hydraulic fluid back into the reservoir tank and allows the hydraulic pressure to go to zero when the park brake is activated by shifting to 'P' and/or turning the ignition 'off'. This dumps the pressure and allows the spring to retract the hydraulic cylinder which engages the park brake when parked.

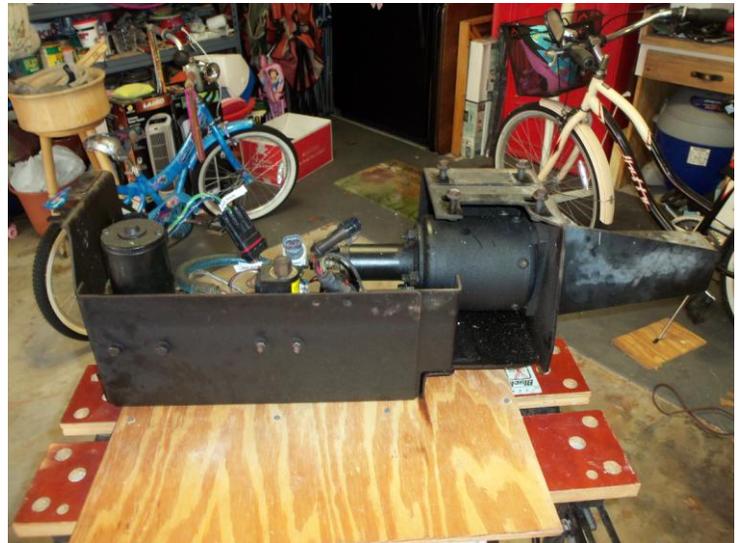
A view from the other side. Nothing to look at here except that the hydraulic cylinder is exposed on this side. The cylinder return spring is in the larger part of the housing.

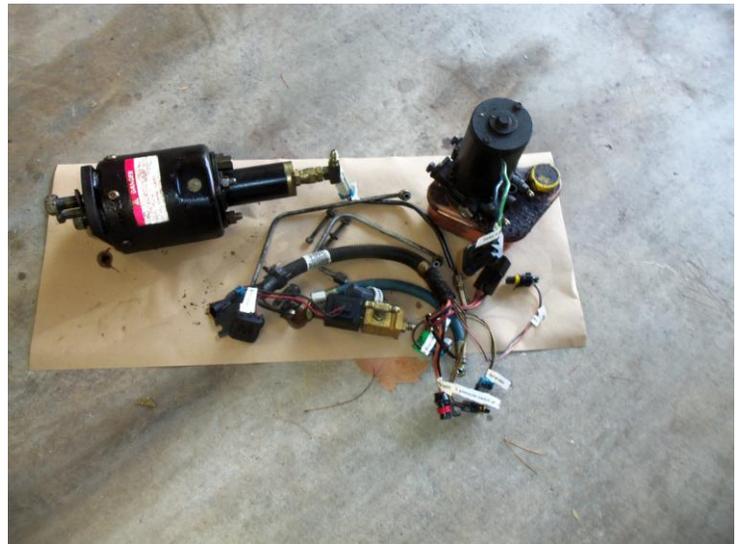
The parts I removed: the hydraulic cylinder (upper left); hydraulic pump with reservoir (upper right); the dump valve (lower center below wiring harness); and the wiring harness (which will be reused). The wiring harness is the only part that will be reused without alteration.

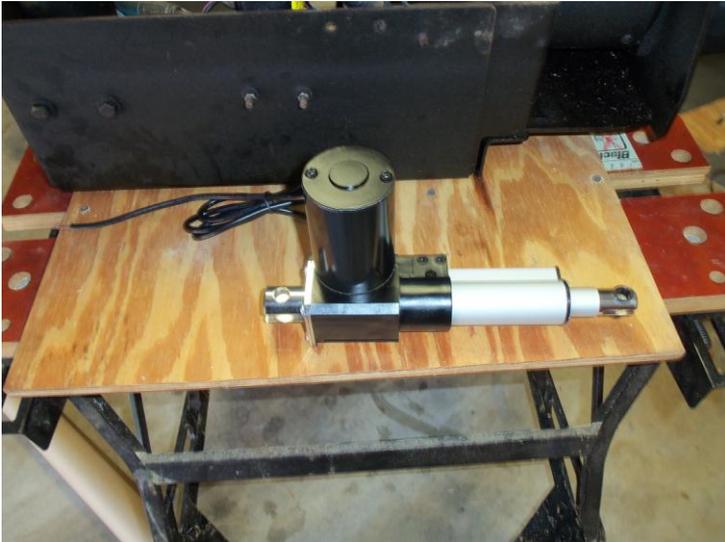
The parts in the previous photo are being replaced with this one part—a 12-volt DC linear actuator with a 3-inch stroke.

I bought this part from Firgelli Automations: Model FA-1000-L-12-3, which has 1,000 lbs. of push force and 800 lbs. of pull force; this one is being used for its pull force.

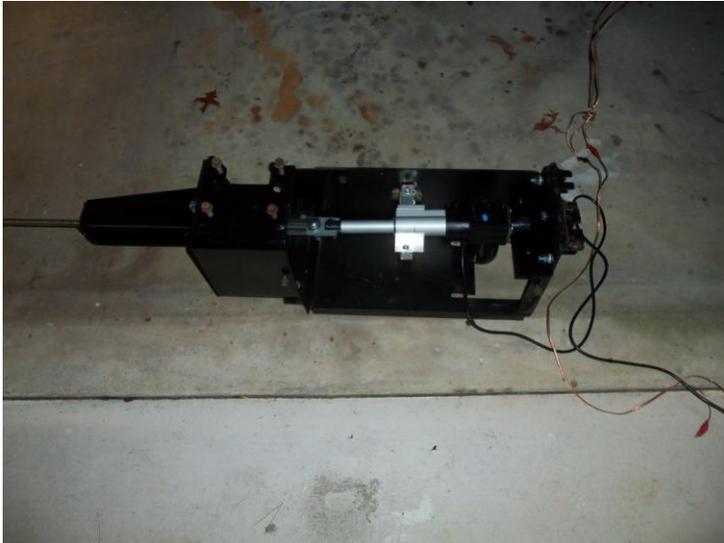
The linear actuator has been installed with a stainless steel 1/2-20 threaded rod. The threaded shaft of the hydraulic cylinder was 1/2-20; I kept the 1/2-20 size and thread to match the coupling nut on the end of the cable. I used stainless steel all-thread rod for its strength to match that of the original threaded shaft.

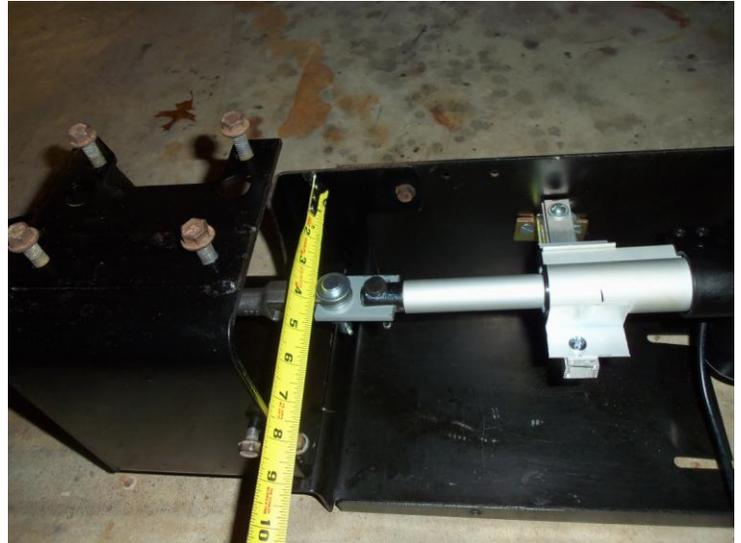
This photo shows testing of the linear actuator operation with the linear actuator in full extension. The tape measure shows the extent of travel and brake yoke pin, compared to the travel when retracted, shown in the next two photos.

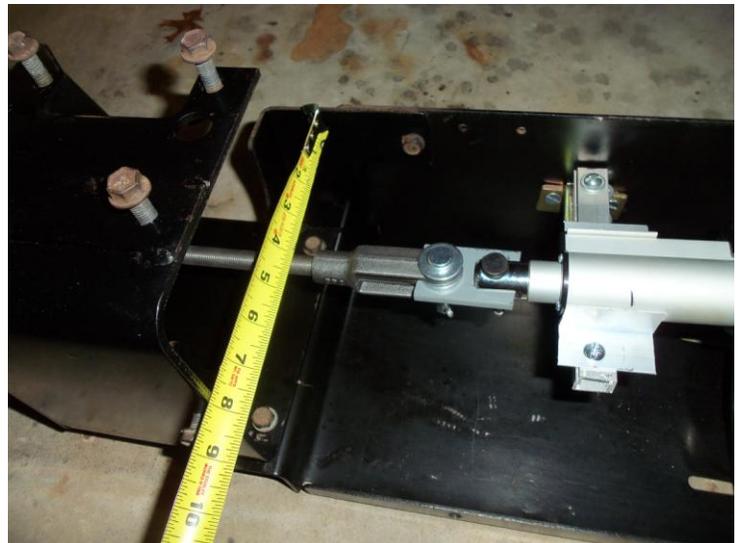
The tape measure shows the location of the brake yoke pin when extended versus the location shown when retracted.

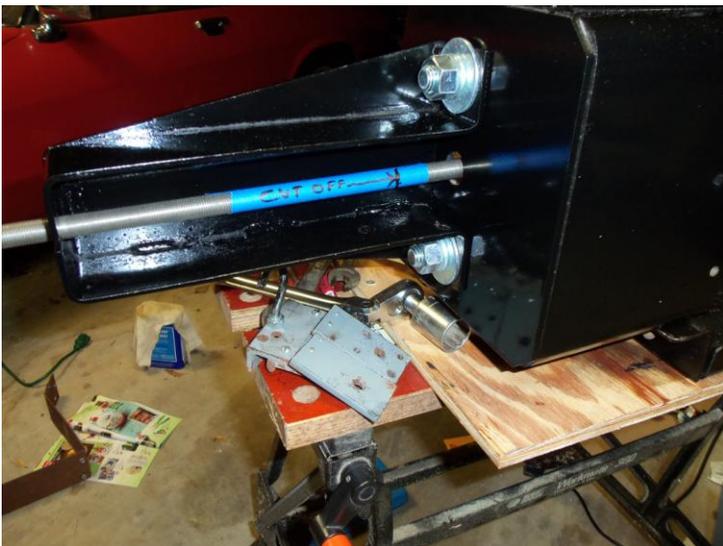
Showing the length the threaded rod will be cut to match the retracted 1-13/16-inch length, measured with the original threaded shaft of the hydraulic cylinder.

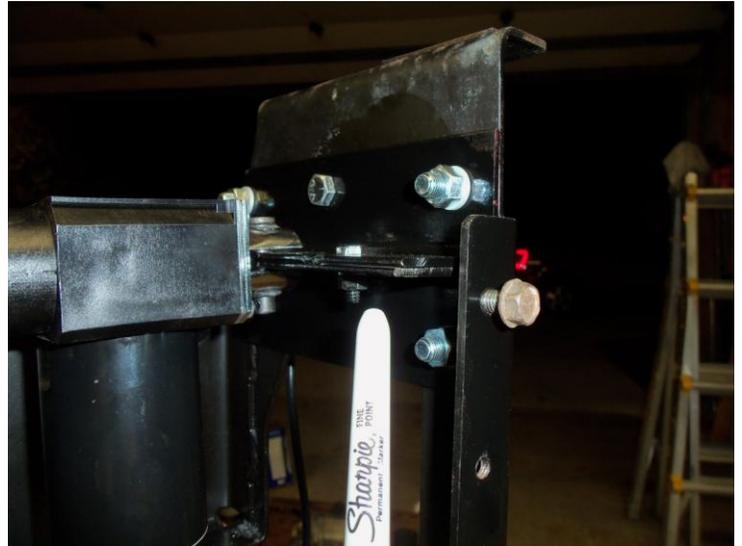
I added this double L angle brace across the end of the unit's box to stiffen the end and provide a mount for this end of the actuator. There is also a side access panel cover that goes on this open side and adds to the rigidity of the end of the box the actuator is mounted to.

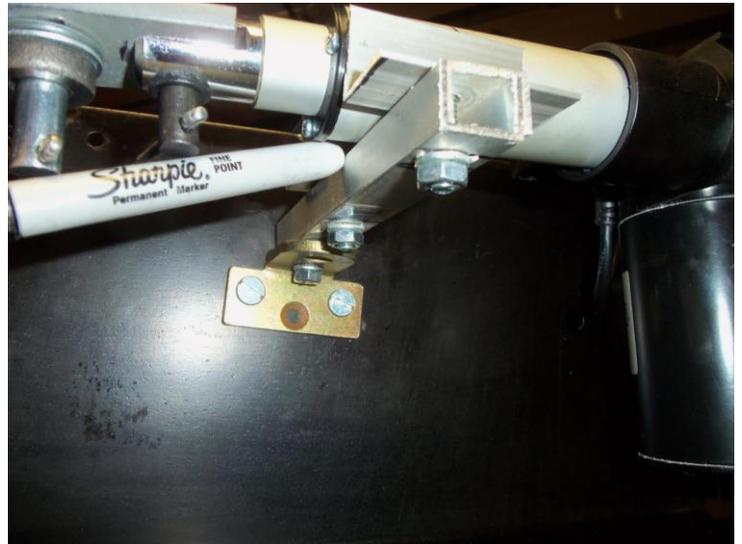
The linear actuator is resting on the bracket I made from two 3/4-inch aluminum channels. I used two holes already in the side of the box to mount the MB3; had to drill one hole out slightly, as the holes were not spaced exactly right.

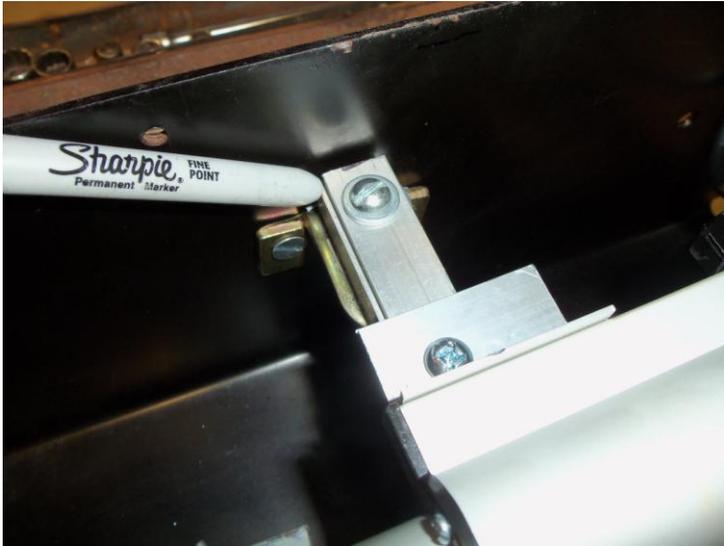
The actuator support bracket is mounted to the MB3 bracket attached to the side of the unit's box.

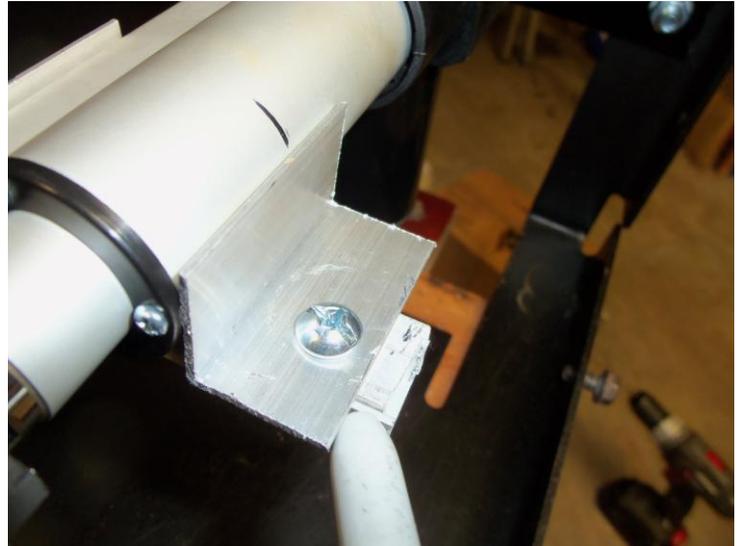
I then installed a bracket to each side of the actuator to keep it centered and in alignment with the hole the threaded rod extends out through to the cable coupling nut.

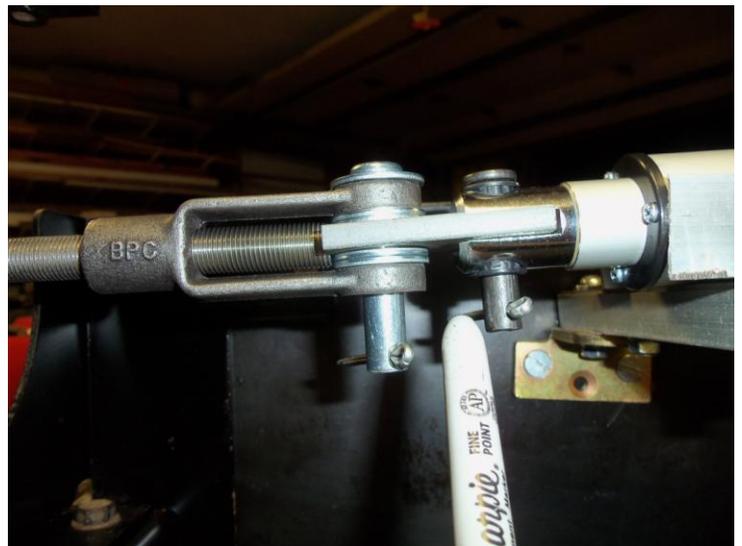
I made a steel flat-bar connector to go from the actuator mounting to the brake yoke.

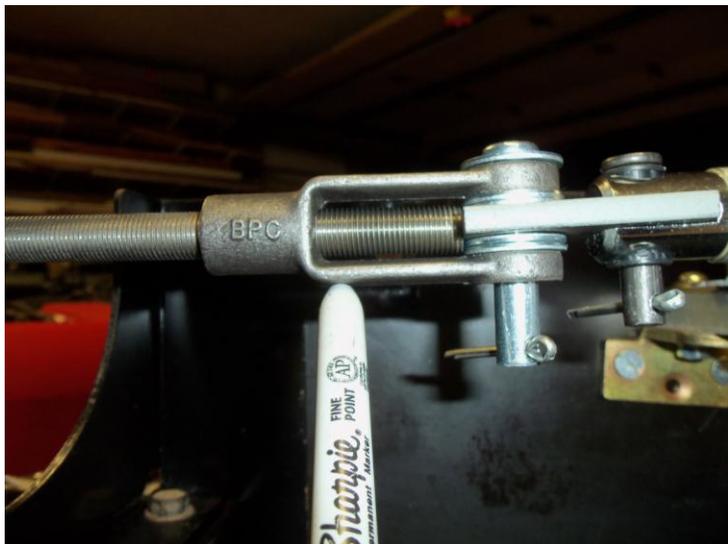
I added a brake yoke, 1/2-20 threaded, to connect the threaded rod to the flat bar connector. I tightened the rod tight to the flat-bar connector to keep proper alignment, as the pins were allowing the connector and brake yoke to move out of straight-line alignment.

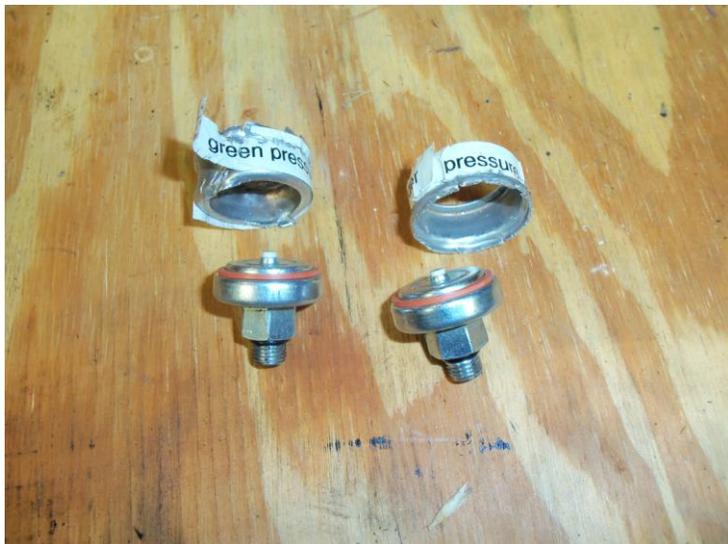
I took the RGS and the other pressure switch (from the inlet at the hydraulic cylinder) and removed the crimped aluminum rings that held the pressure section to the switch body.

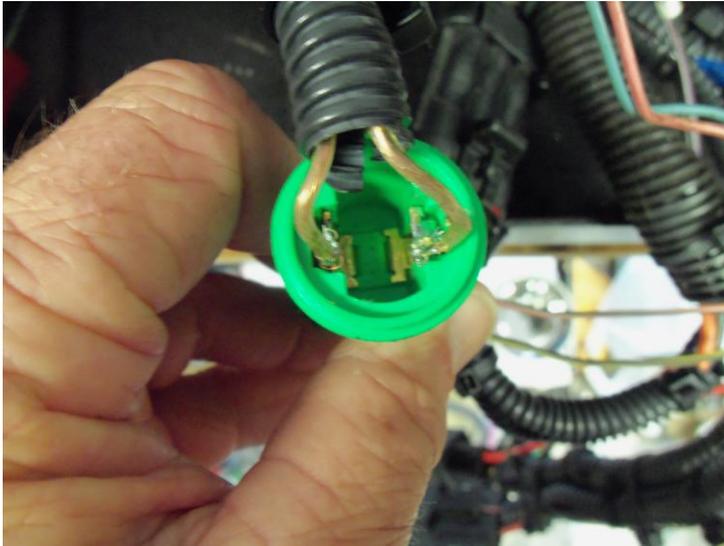
This is the RGS with the pressure section removed and wires soldered to the contacts.

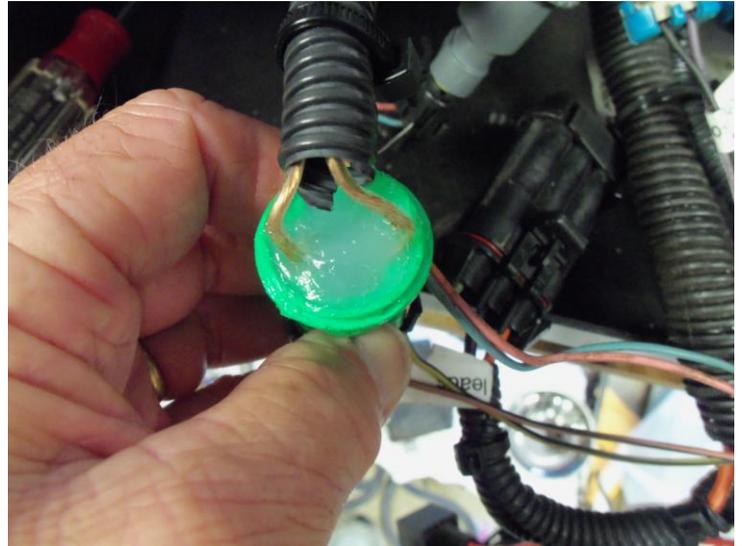
After soldering the wires to the contacts and making sure the connections were good, I filled the switch body with dielectric sealant.

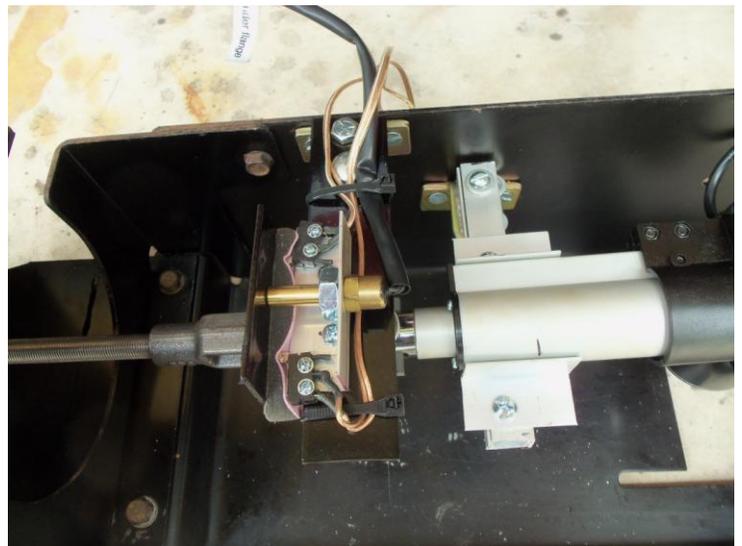
I used the other MB3 mounting bracket as a support for the piece I mounted the three switches to. The two side switches are for the RGS and the other pressure switch. The center switch is the switch that was mounted in the hydraulic cylinder at the spring to indicate when the brake was not fully on.

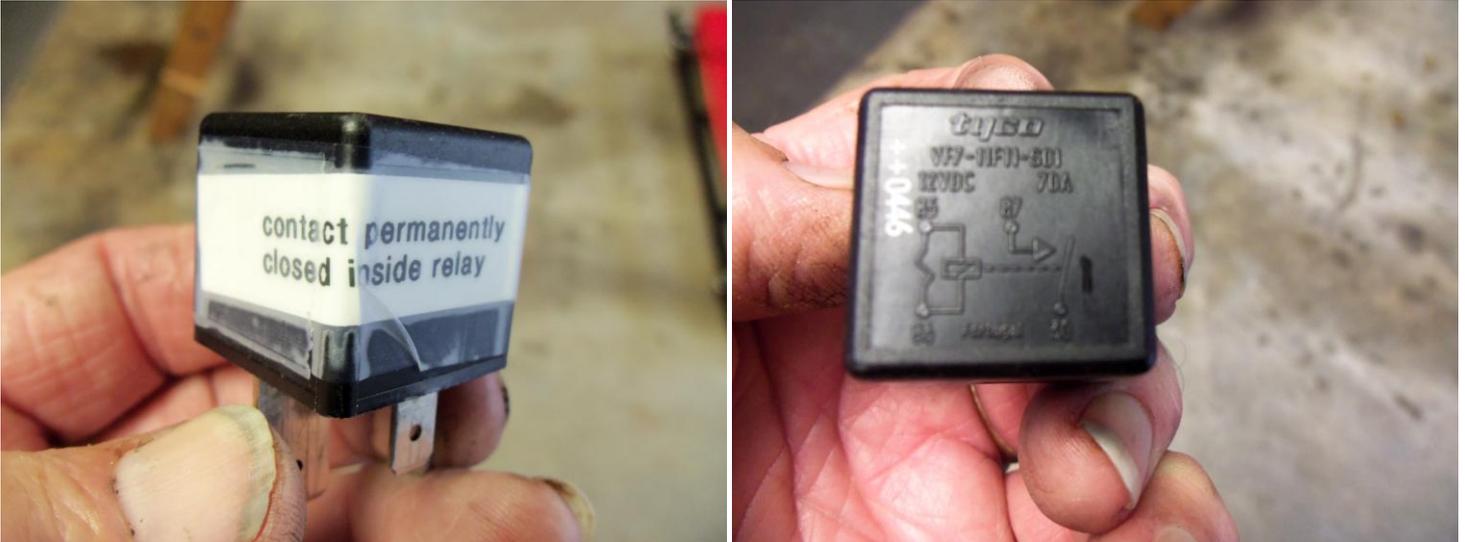
The way I reversed the polarity to the actuator was to connect the motor leads to the NC contacts of two new relays I added; this powers the actuator. I then connected the leads from the dump valve (this dumps the pressure in the hydraulic system). Instead of opening the dump valve, this power now operates the relays, opening the NC contacts and closing the NO contacts.

When the transmission is in Park and the ignition is on, there is power to the dump valve – this causes the relays to switch from the NC contacts to the NO contacts and reverses the polarity to the actuator (this causes the actuator to retract and apply the park brake).

When the transmission is shifted out of Park (with ignition still on) and into Reverse, Neutral, or Drive there is no power to the dump valve – this causes the two new relays to switch from the NO contacts to the NC contacts and reverses the polarity to that actuator (this causes the actuator to extend and release the park brake). Each operation of the relays reverses the polarity of the voltage to the actuator and causes the actuator to operate, i.e., if the actuator is extended it will retract, and if retracted it will extend.

When the transmission is shifted out of Park (with ignition switch still on) and into Reverse, Neutral, or Drive and the 'Park Brake' switch is switched 'on', power is applied to the dump valve – this causes the relays to switch from the NC contacts to the NO contacts and reverses the polarity to the actuator (this causes the actuator to retract and apply the park brake the same as if the transmission was shifted into Park).

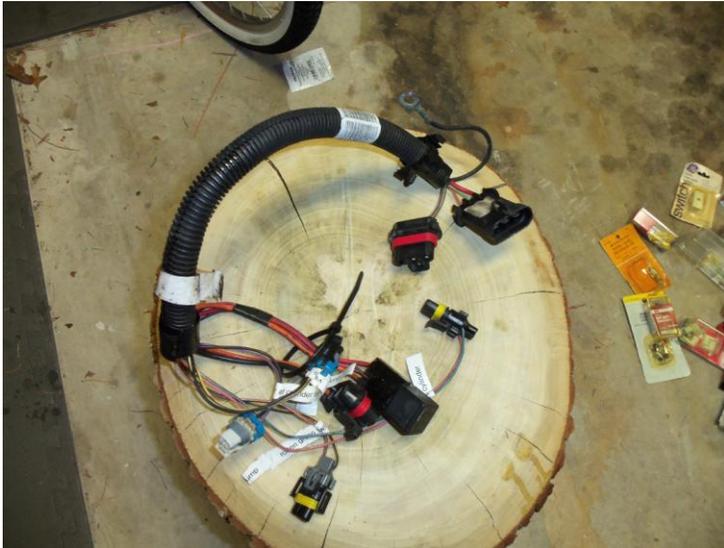
The factory wiring harness, which is part of the park brake unit. This is reused without alteration; the two connectors at the top of the harness connect to two connectors on the chassis, the ground connected to a bolt in the park brake unit housing.

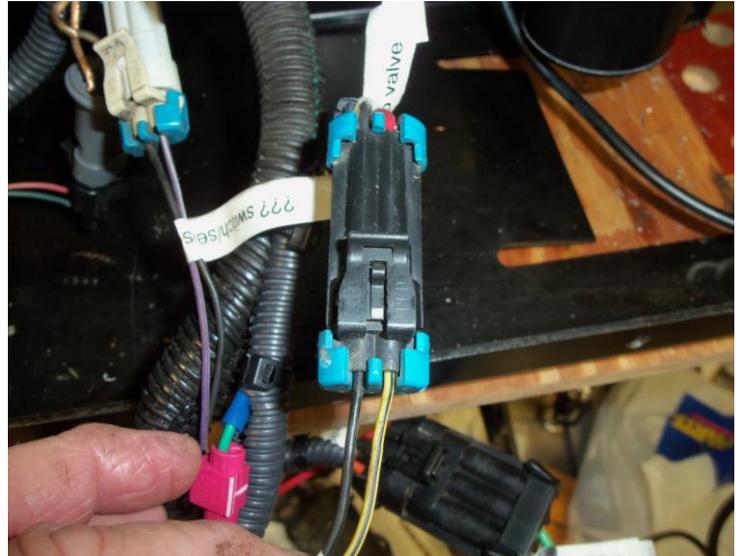
The connector from the dump valve switch. It now provides power to the two new relays, which reverse the polarity as needed to the actuator to extend or retract it. It connects with its matching factory connector because the factory wiring harness was not altered.

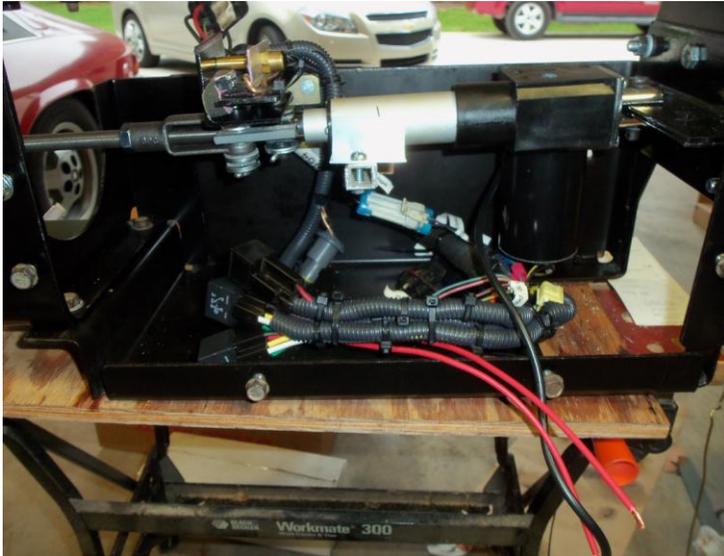
Completed assembly showing the uncomplicated design of the 12-volt linear actuator compared to the original hydraulic system, which was much more complex; see photo at right.

The photo at upper left also shows where I added washers at the brake yoke/connector plate pin and connector plate/actuator pin to serve as shims to align the various parts and to take the slack out of the extra length of the pins. I also added a jamb nut on the 1/2-20, threaded tight against the brake yoke to keep the rod from becoming loose in the brake yoke. Everything is now snug-fitting and tight.

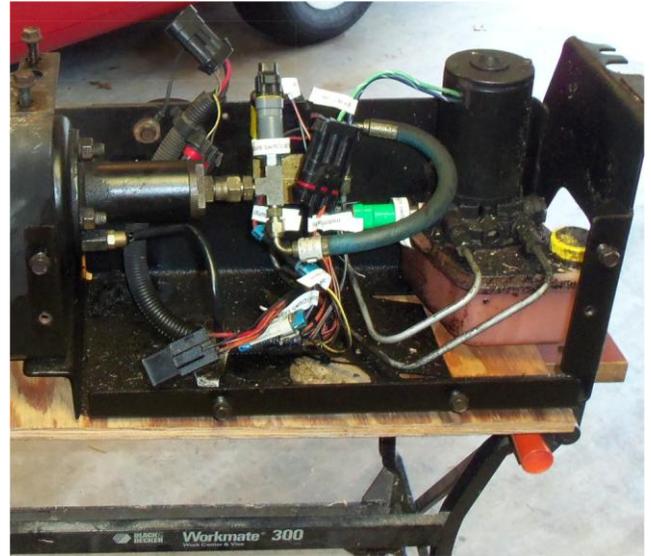
The original hydraulic system, which is prone to leaking and failure while driving.

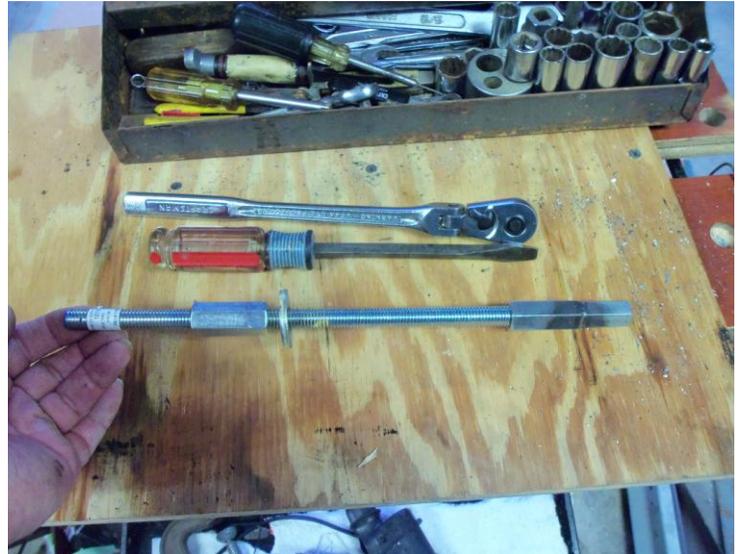
The tool I made to pull against the internal spring in the hydraulic cylinder to check the stroke length of the original park brake assembly.

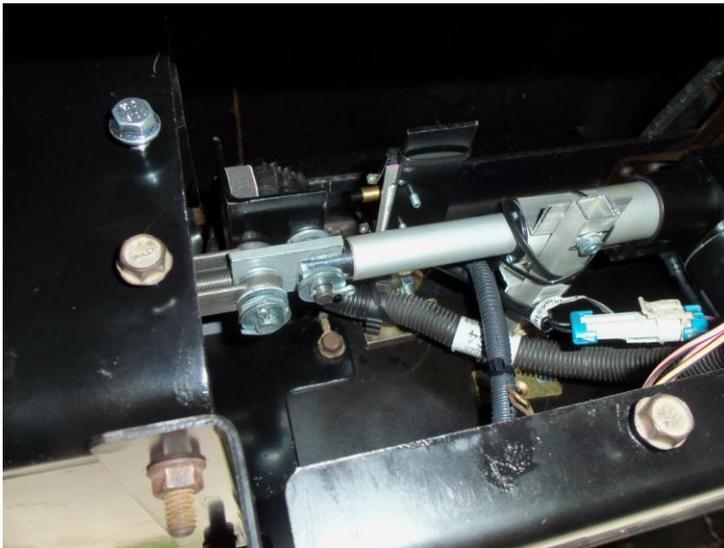
The installed park brake unit with the actuator extended (brake off).

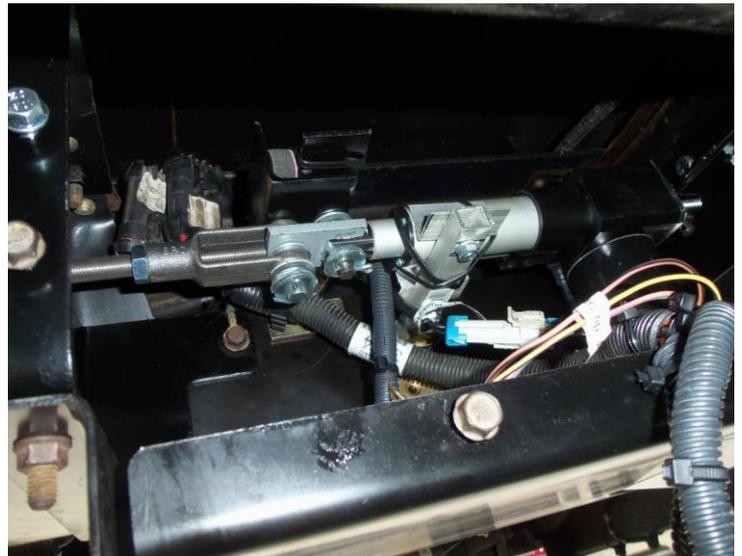
The installed park brake unit with the actuator retracted (brake on).

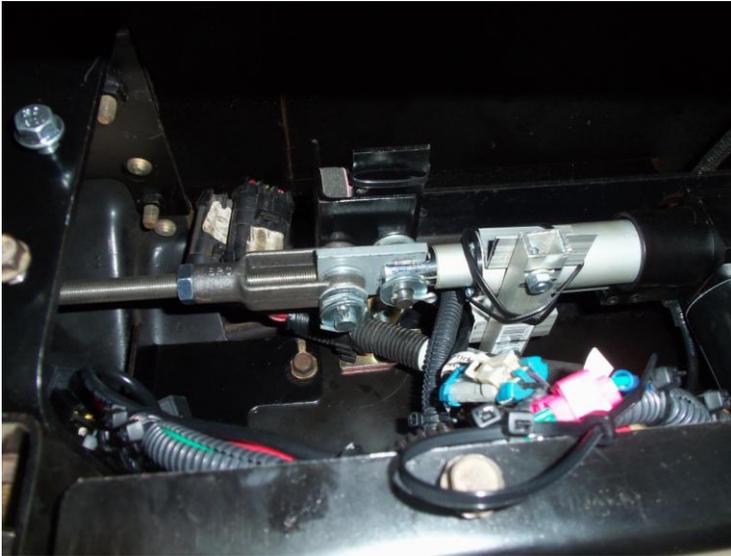
A view of the completed and installed unit prior to installing the access cover plate. For good measure, I installed two black cable ties X-fashion around the actuator to hold it down so it does not bounce or move up and down. It did not move during my testing, but I want to make sure it also does not move while driving.
